NACA RM E54K17

PERFORMANCE OF AS-FORGED, HEAT-TREATED, AND OVERAGED  
S-816 BLADES IN A TURBOJET ENGINE

By J. W. Weeton, F. J. Clauss, and J. R. Johnston

Lewis Flight Propulsion Laboratory  
Cleveland, Ohio

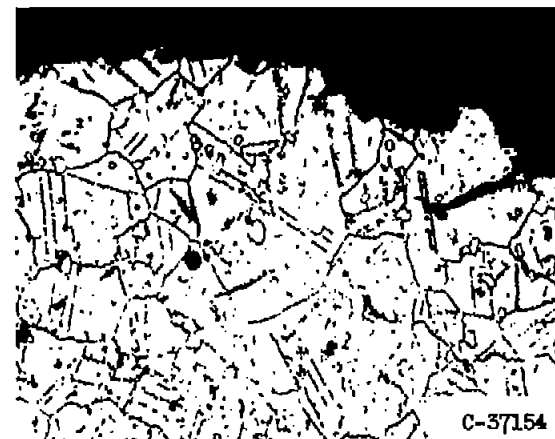
Figure 8. - Continued. Microstructures of failure origins or areas near failure origins in first and last blade failures.

Stress-rupture characteristics of failure occur at jagged failure origin, irregular fracture edge, and intercrystalline tear.

Fracture originated 1/4 in. from leading edge and progressed in transcrystalline manner indicative of fatigue.

The structures of Air Force stock blades given the standard heat treatment are shown in figure 8(g). There is a noticeable difference between the structures of the blade failures of this group and those of the blade failures of group 3, which also received the standard heat treatment. The Air Force stock blade which failed first has much less general precipitation than the specimens of group 3, and the first failure time is less. Grain boundary precipitates and residual carbides appear to be the same in both groups, but the grain size of the specimen of group 7 is finer than that of group 3. This could be the result of forging variables. An interesting but unexplainable happenstance is that all failures of group 3 originated at the trailing edges, whereas all failures of group 7 originated at the leading edges. Stress-rupture and fatigue characteristics are present in the photographs of the first and last failures, respectively.

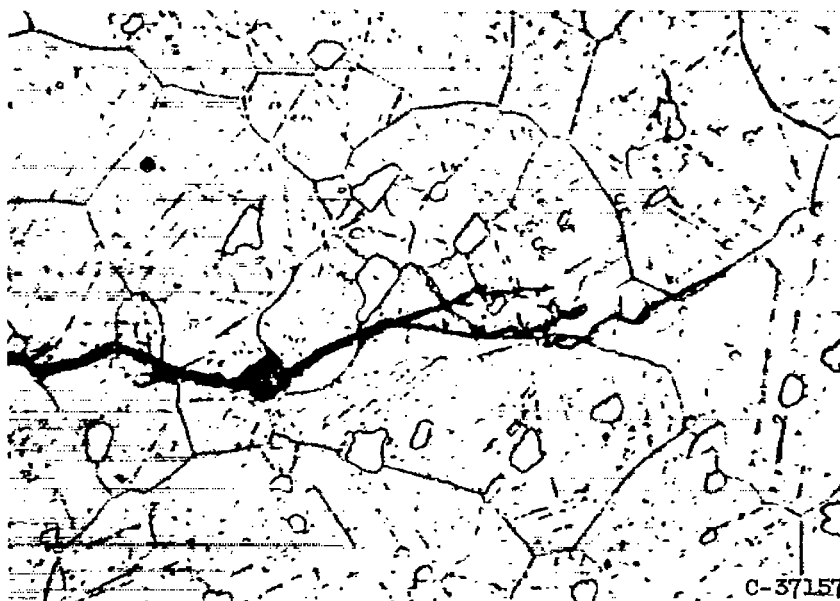
Figure 9. - Typical stress-rupture and fatigue cracks associated with main fracture.

Stress-rupture portion of fracture edge and typical stress-rupture cracks. Etched in 5 percent aqua regia in water electrolytic followed by 10 percent HCl in alcohol electrolytic.

Fatigue cracks which radiated from main fracture edge which failed by stress-rupture followed by fatigue. Etched in 5 percent aqua regia in water electrolytic followed by 10 percent HCl in alcohol electrolytic.

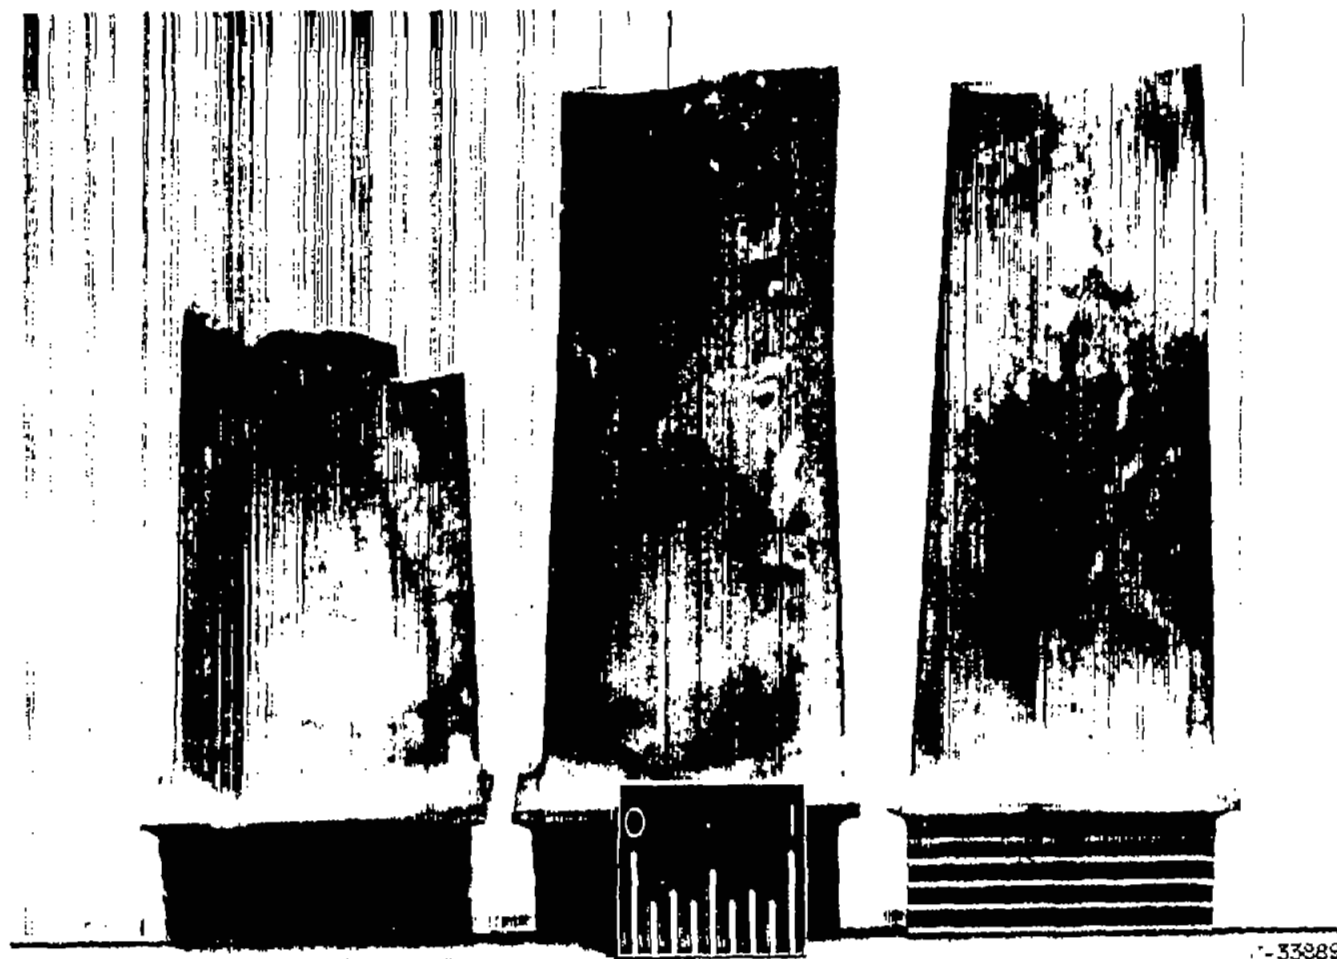
Figure 10. - Blades of group 5 with germinated grains revealed by macroetching.

(a) Blade 1. Failed by stress-rupture in 285.17 hours.

(c) Blade 6. Failed by stress-rupture cracking in 49.25 hours.
